**INSTRUMENTATION AND DEFORMATION MEASUREMENT OF
CHARLOTTE COUNTY CULVERT NO. 2. USING SHAPEARRAY
TECHNOLOGY**

A Report Submitted in Partial Fulfillment
of the Requirements for the Degree of

DE03 (Route 127) Culvert No. 2, is an existing corrugated steel pipe (CSP) culvert in Charlotte County, southwest New Brunswick, chosen for load test, field instrumentation with ShapeArray and LiDAR monitoring in this project. In this study, ShapeArray (SAA), was mounted inside the pipe in a circular orientation and utilized to record displacement in the middle of the culvert. Field work consisted of performing static and dynamic loading tests using NBDTI standard test vehicle, with only static loading test results presented in this study. Twenty static load tests were completed, ten times in each traffic direction. In addition to the SAA data, Laser Scanning survey method (LiDar) was used to assess culvert deformation along the culvert.

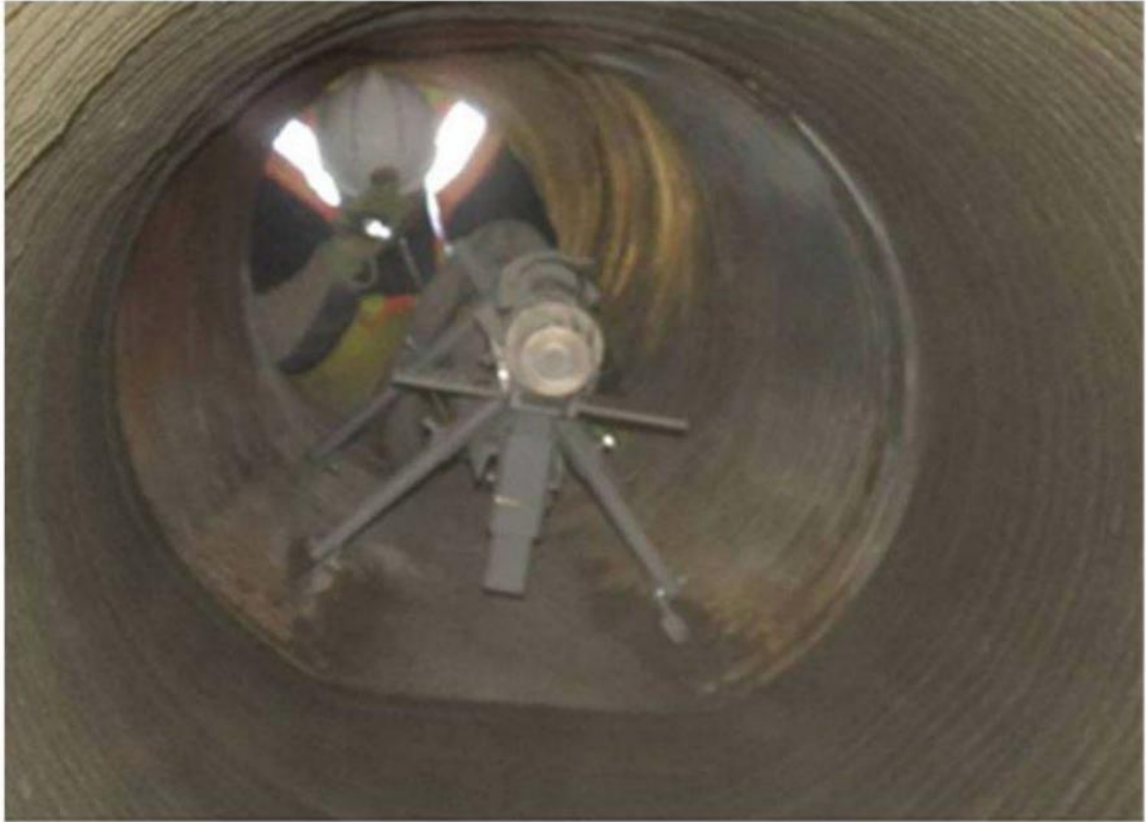
Figure 2.1. Centrifugally Cast Liner Installation [2].

As seen in Figure 2.1, centrifugally cast liners are liners that are installed in the interior of the culvert by a spinning head that is powered by air or electricity. Liner’s material can be cementitious mortars, polymers etc. These materials are typically used on CSP culverts to increase structural strength and give corrosion protection. Pipes with diameters of 75 to 300 centimeters can be lined with this method. The thickness depends on the speed of cast and how fast the machine is moving through the culvert.

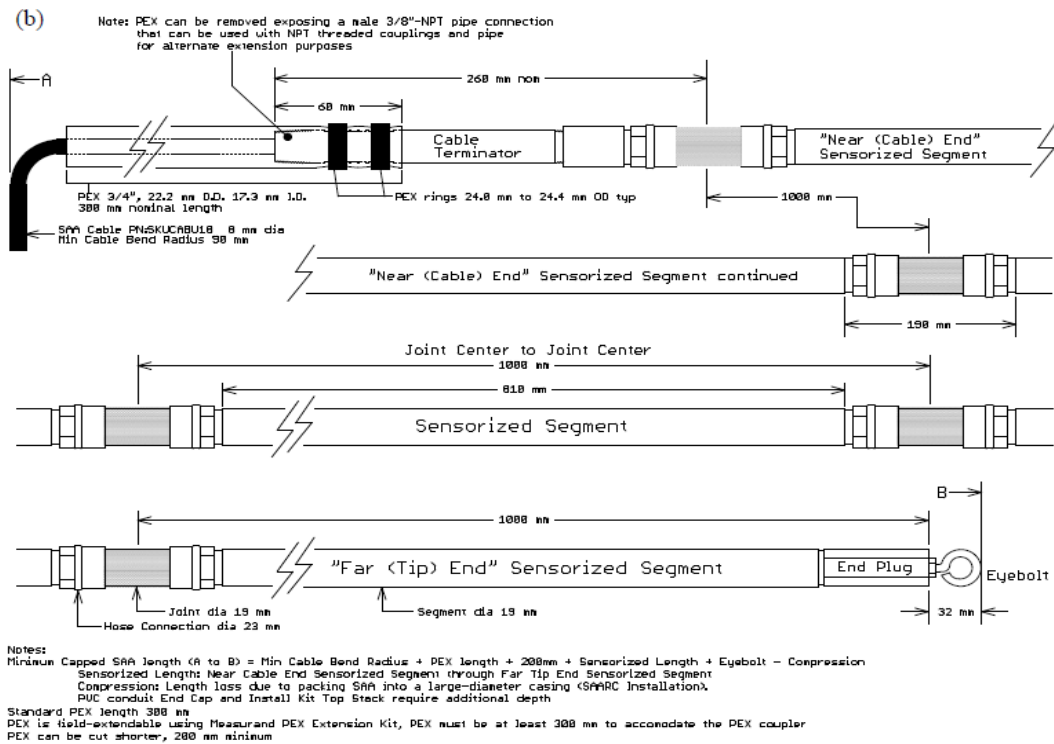
Figure 2.4. Horizontal SAA (a) On rolls for transportation and (b) Dimensions and configuration

ShapeArray sensors (SAA) is an instrumentation that can measure small deformations by monitoring the structure continuously. A site with ground's soft spots, located in Sarnia, Ontario, Canada, at Mile 13.75 of the CN Rail St Clair Subdivision, was monitored with two methods of instrumentational monitoring, SAA and LIDAR scans. Track settlements have been investigated by both methods and results have compared to each other to evaluate methods performance and accuracy. The data gathered from The SAA was comparable to that from LIDAR with the additional advantage of measuring settlement of the track. Long-term rail settlements at this location were discovered to depend on seasonal and climatic factors, with slower rates during the winter and higher rates during the summer [6]. Figure 2.4. shows the SAA rolls and dimensions and configuration of ShapeArray instrumentation.

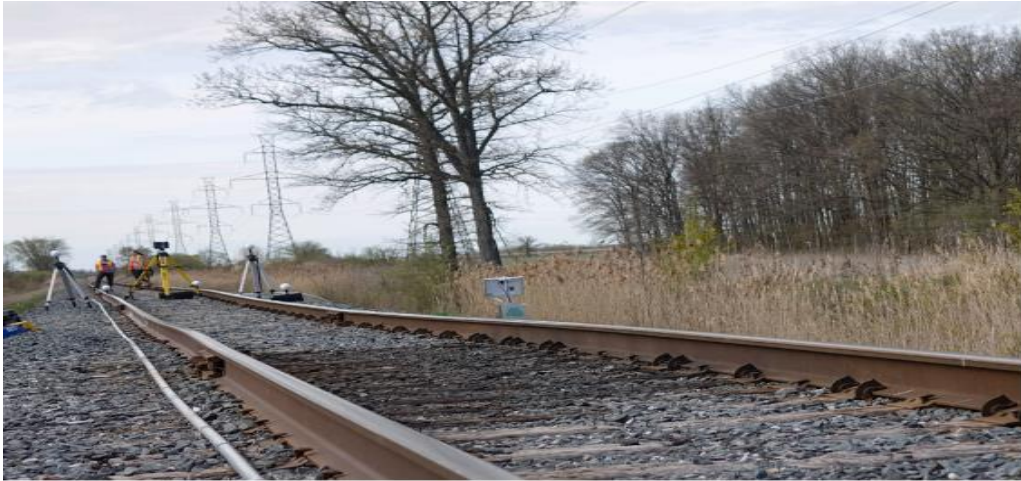
Figure 2.5. Sarnia test site (a) monitored track depression and (b) installation detail of the SAAs enclosed in steel conduits attached to the ties [6].

Two 40 m long SAA sensors were installed on the sleepers on each side of the track and deformation was measured under environmental loading and revenue service loading with two trains travelling daily through the monitored section over the nine-month monitoring period (August 2018 to May 2019). Full LIDAR scans of the track were conducted at the time of the SAA installation (baseline data), after small deformations (~5–10 mm), and after large deformations (~100 mm). Figure 2.5. shows the site and SAA installation details [6].

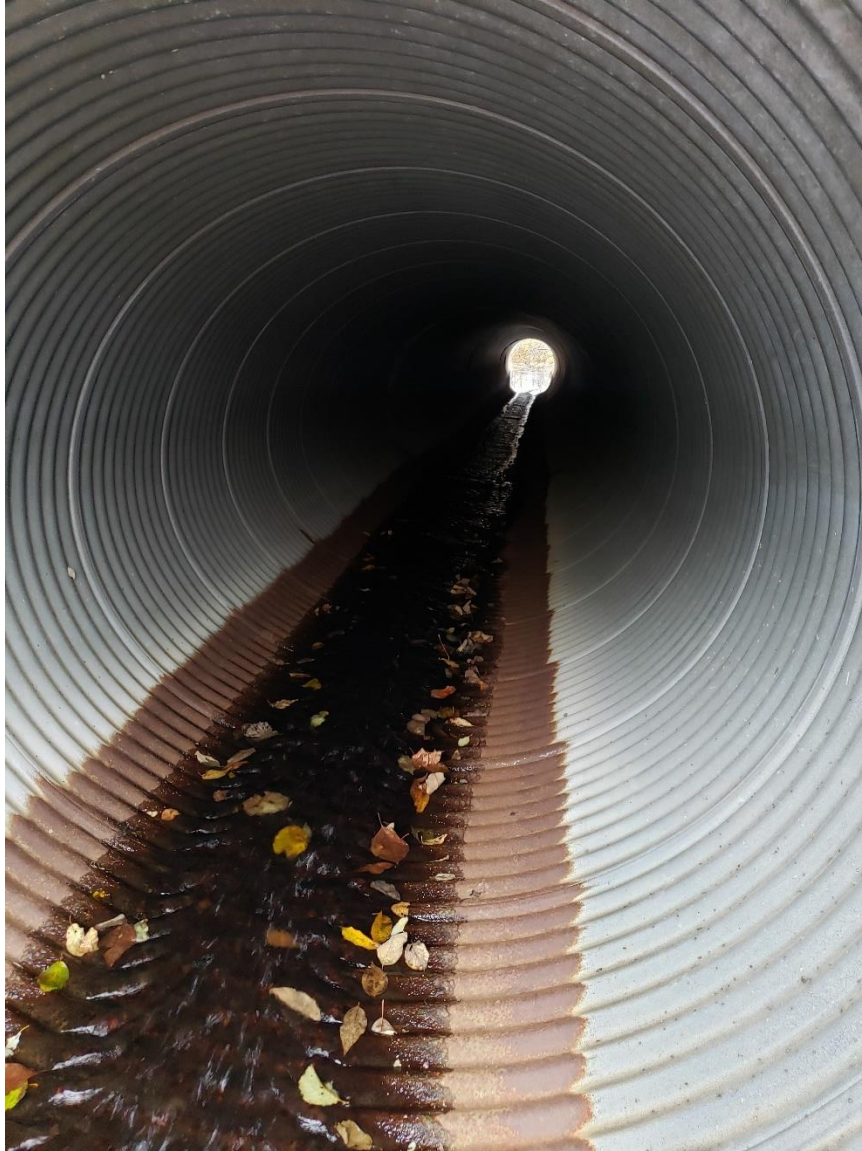
Figure 3.3. CSP, view from the northern entrance

The invert, crown, or sidewalls of the pipe are examined throughout the cleaning process, and deteriorated sections were repaired to create a constant slope to the pipe. Prior to lining the pipe, all open joints are filled with grout or the geopolymer lining material. The pipe's interior walls and floor were thoroughly cleaned and clear of any dirt, rocks, sediment, or other objects that could prevent the geopolymer from bonding to the host pipe. Active leaks

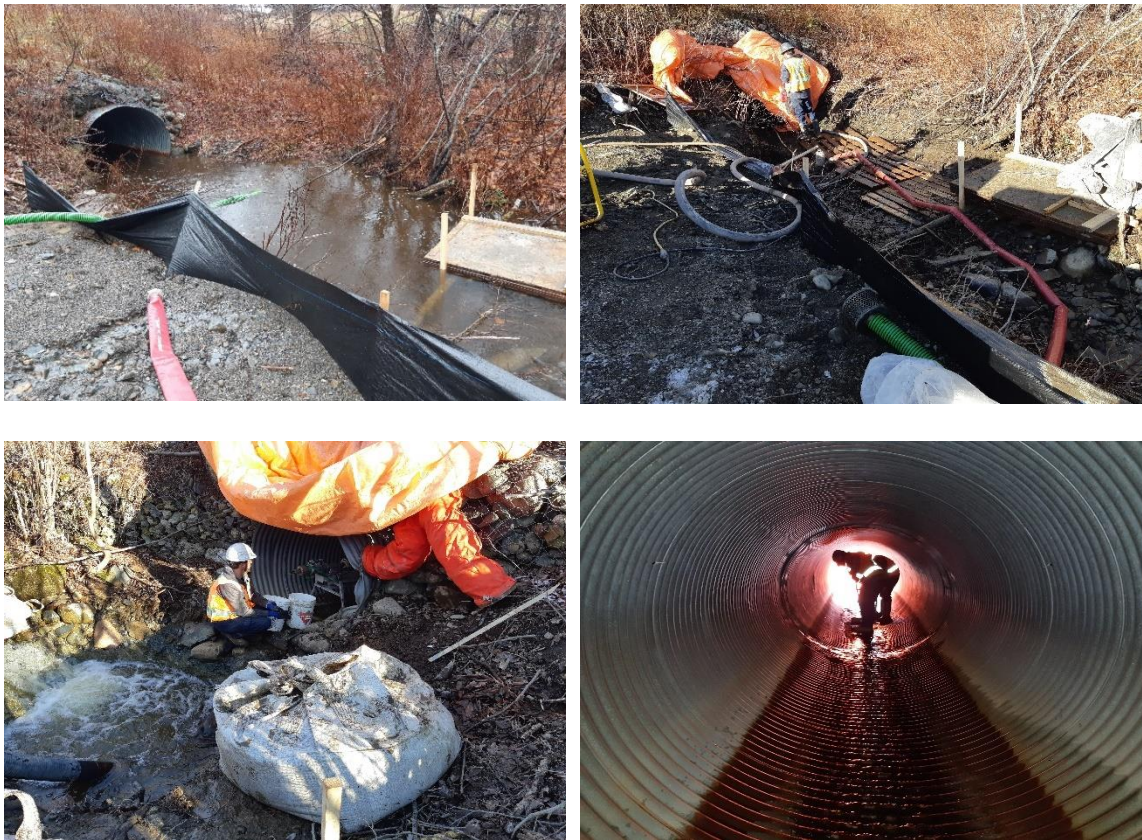
Figure 3.4. Southern side of CSP before pumping (top left), Southern side of CSP after pumping (top right), northern entrance of CSP during pumping (bottom left) and stopped flow culvert and cleaning process (bottom right).

To control and stop water flow inside the CSP and discharge the collected water in the open area at the southern side of the CSP, a pumping station was constructed at the northern entrance of the culvert as shown in Figure 3.4.

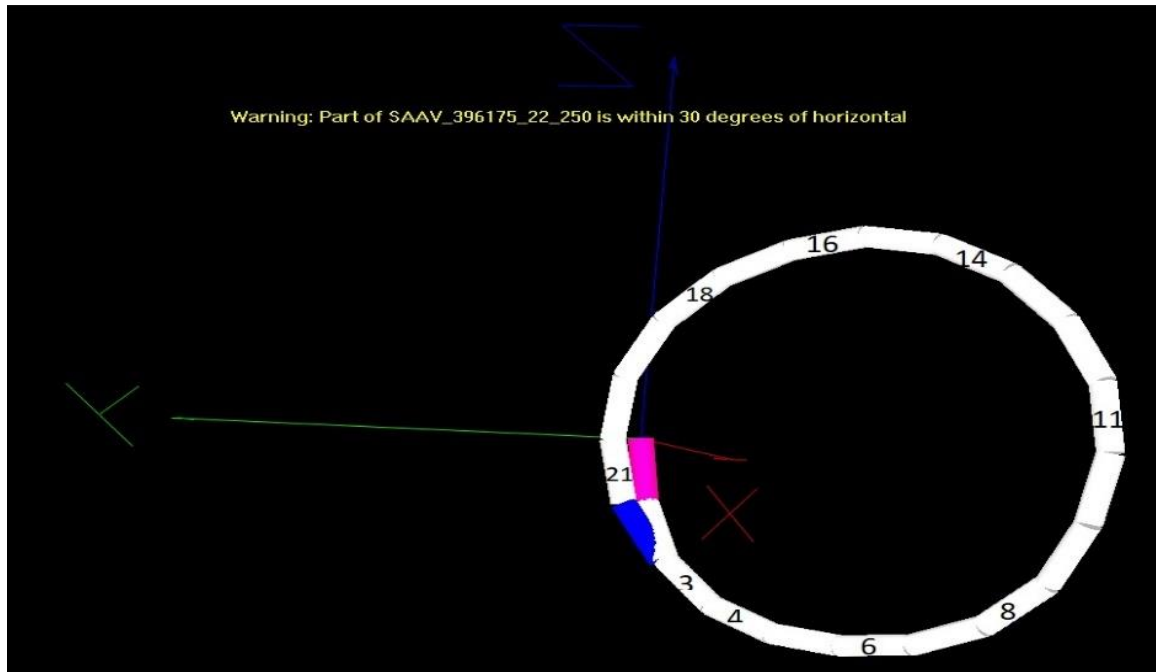
Figure 3.5. ShapeArray segments orientation.

extended cable of SAA, tightened to the culvert by pipe strap and wall screws. Conduits contain extended cable of ShapeArray , tightened to the crown of the culvert and extended to the data acquisition system (DAS) box. SAA had twenty-two segments, with the first segment shown with pink color and last segment has blue color as is shown in Figure 3.5.

Each segment of SAA records a specific coordinate as a signal and the data is transferred to DAS (segments 10, 11 20 and 21 are springline, segments 4 to 8 are invert and 14 to 17 are culvert crown). The data logger contains a sensor to receive the information and a computer chip to store it. The information stored in the data logger is transferred to a computer for analysis. In this study DAS is powered by a car battery and solar panel. In addition to the SAA data, Laser Scanning survey method (LiDAR) is used to assess culvert deformation before and after lining application. A 5-meter section of the culvert's length was used for the whole scan (2.5-metres on either side of the Centre of the culvert). Each

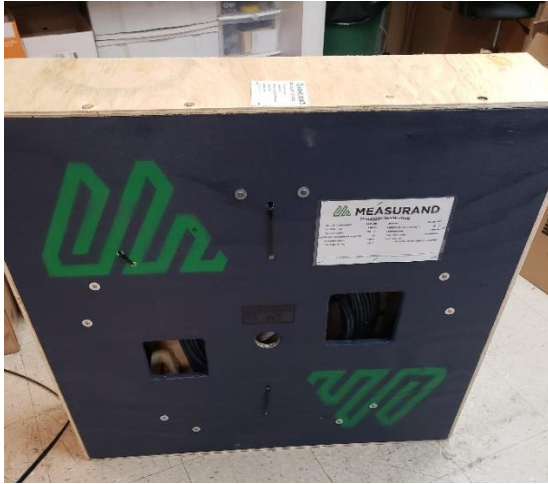
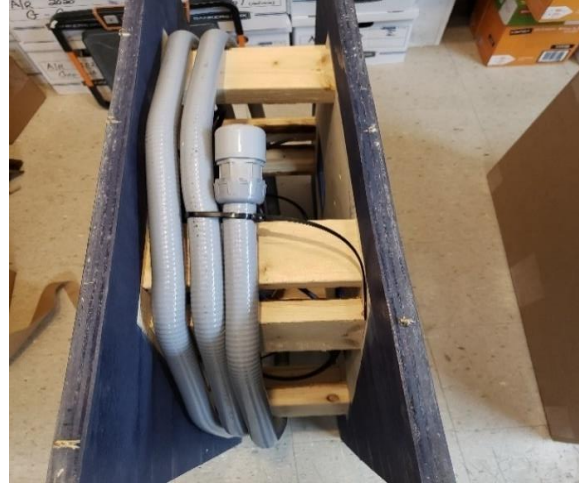
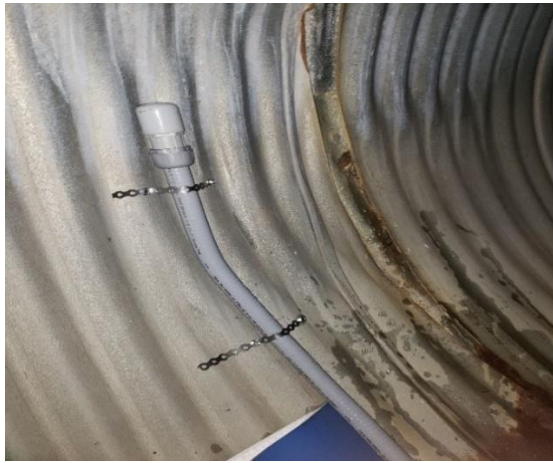
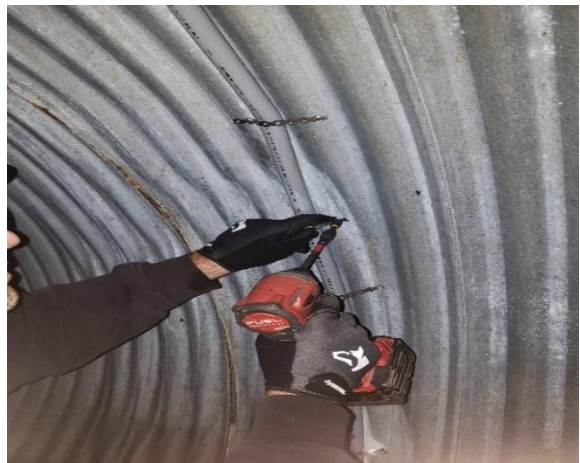
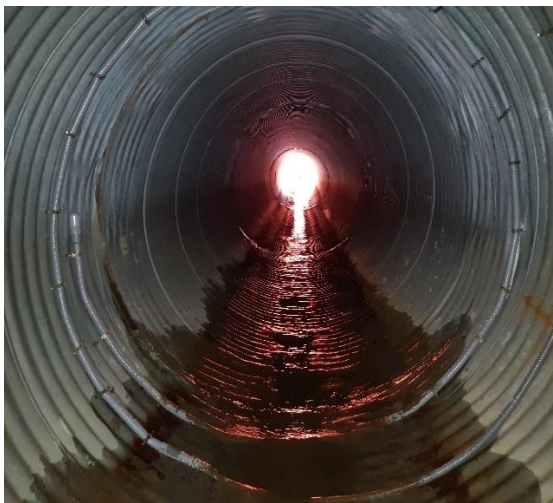
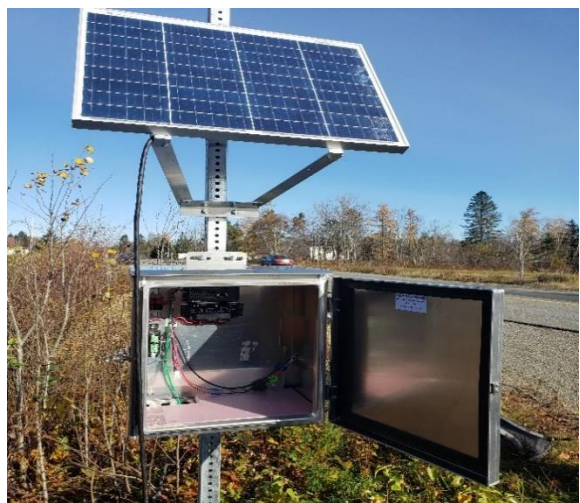
Figure 3.6. ShapeArray before unboxing (top left and right), ShapeArray tightened to the culvert by pipe strap and wall screws (middle left and right), All segments installed ShapeArray orientation (bottom left) and DAS box (bottom right).

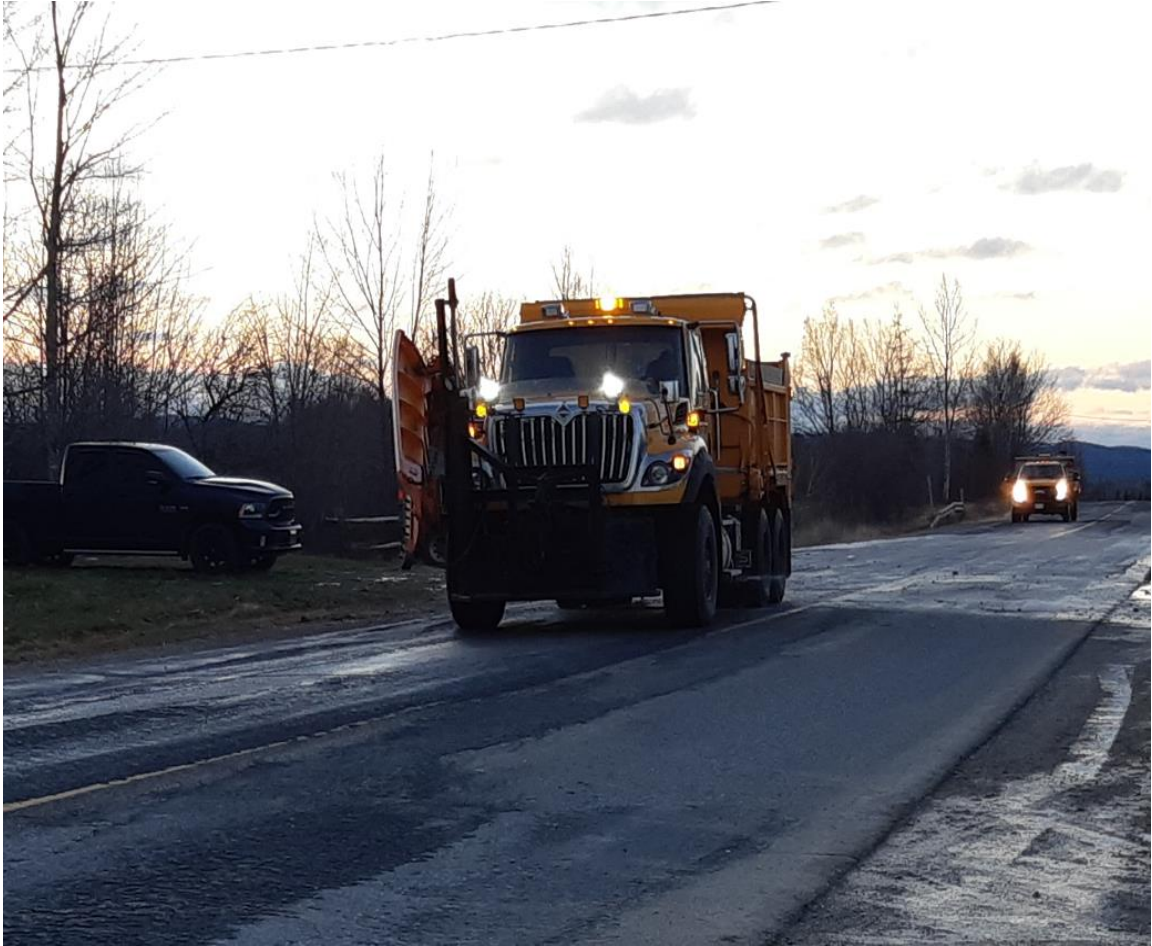
Figure 3.7. Loaded test truck.

The static load testing was undertaken on Wednesday November 3rd, 2021. The test vehicle was a dump truck weighing 14,340 kg which was supplied by NBDTI and was used to conduct static load testing. The truck was loaded with 6,420 kg of gravel bringing the total weight of the truck to 20,760 kg. The test truck is shown in Fig. 3.7.

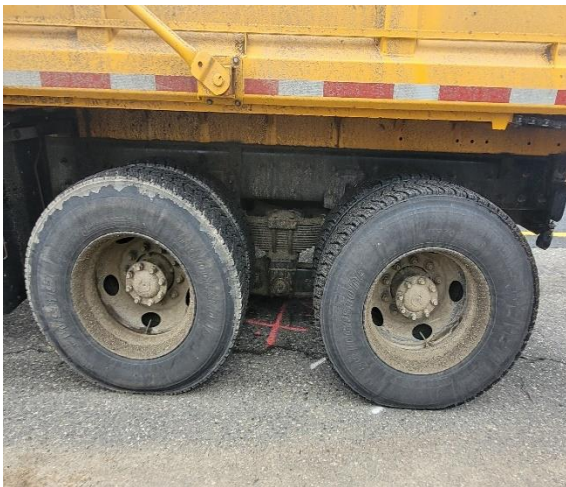
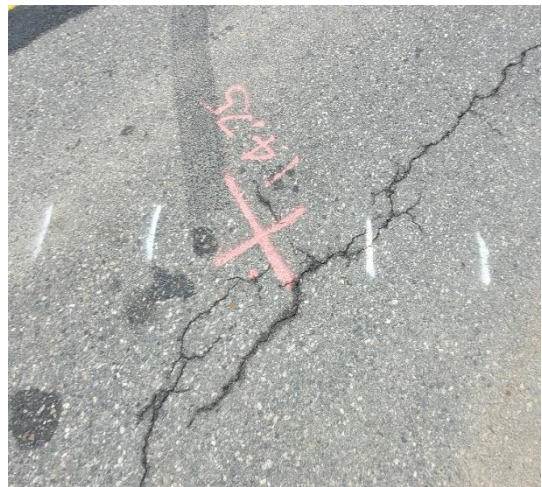
Figure 3.8. Test location over the culvert and truck position.

Twenty static load tests were completed, ten times in each traffic direction before and after lining application. The test locations (five spots) for the truck over the culvert during the static tests was the exact middle spot of the culvert under the right lane of the road from north to south (14.75 meters away from northern entrance of the culvert). The truck was positioned over each location for approximately 20 seconds before moving to the next location as shown in Figure 3.8.

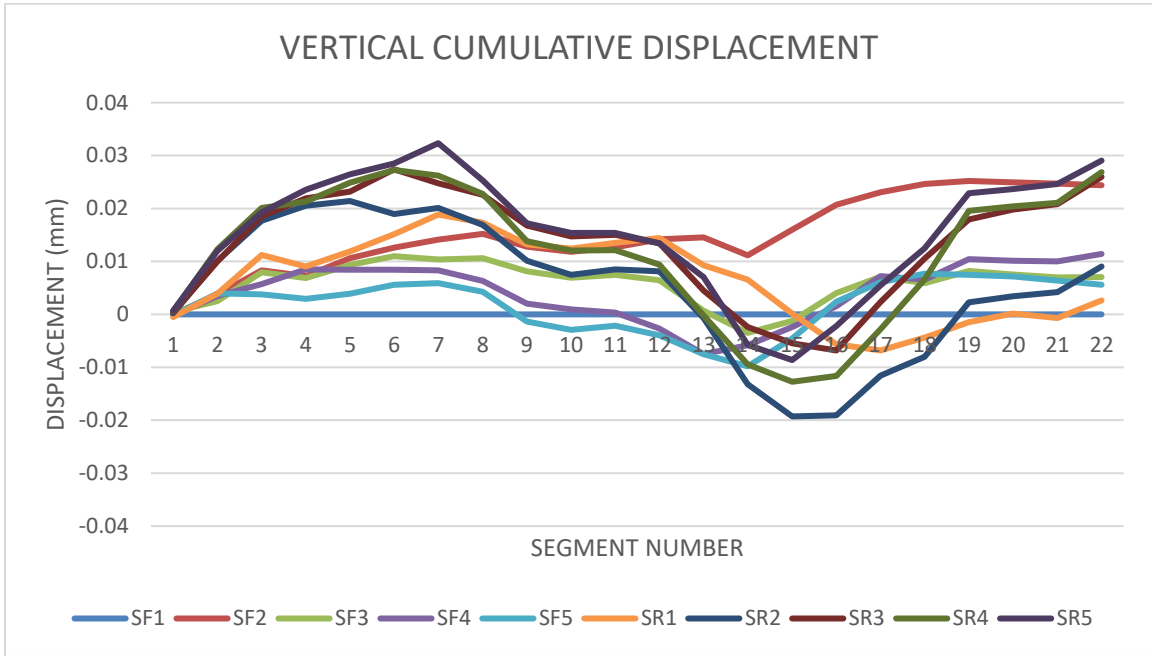
Figure 3.9. Vertical cumulative displacement in south direction before lining application.

Displacement data gathered from SAA in the south direction of the road over the culvert is presenting in Figs. 3.9. and 3.10.

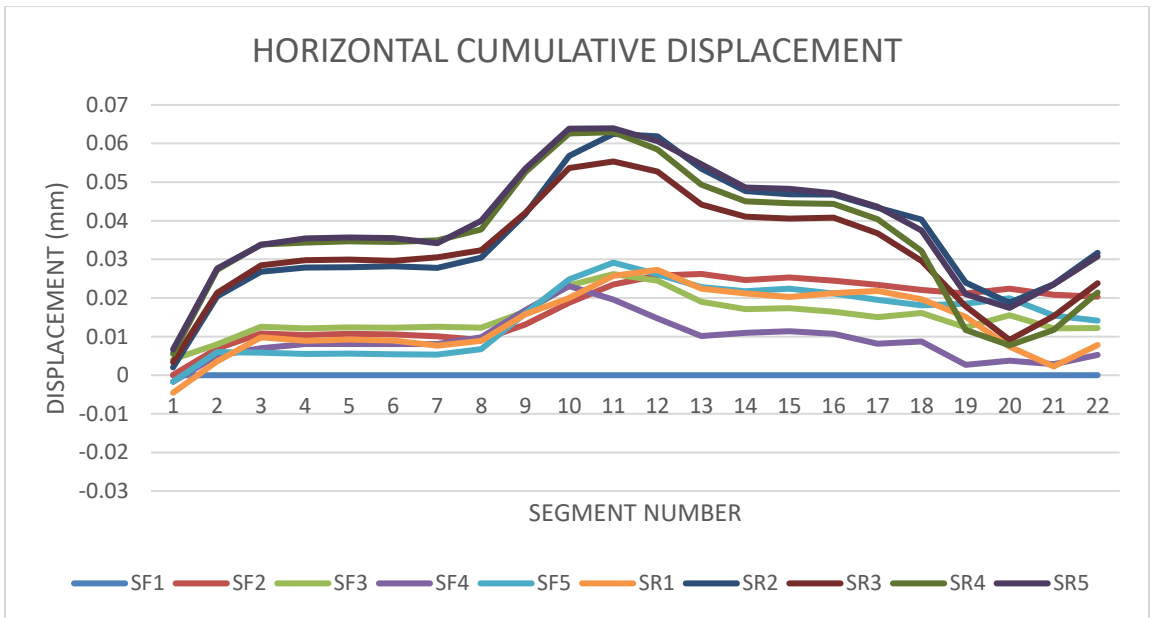
Figure 3.10. Horizontal cumulative displacement in south direction before lining application.

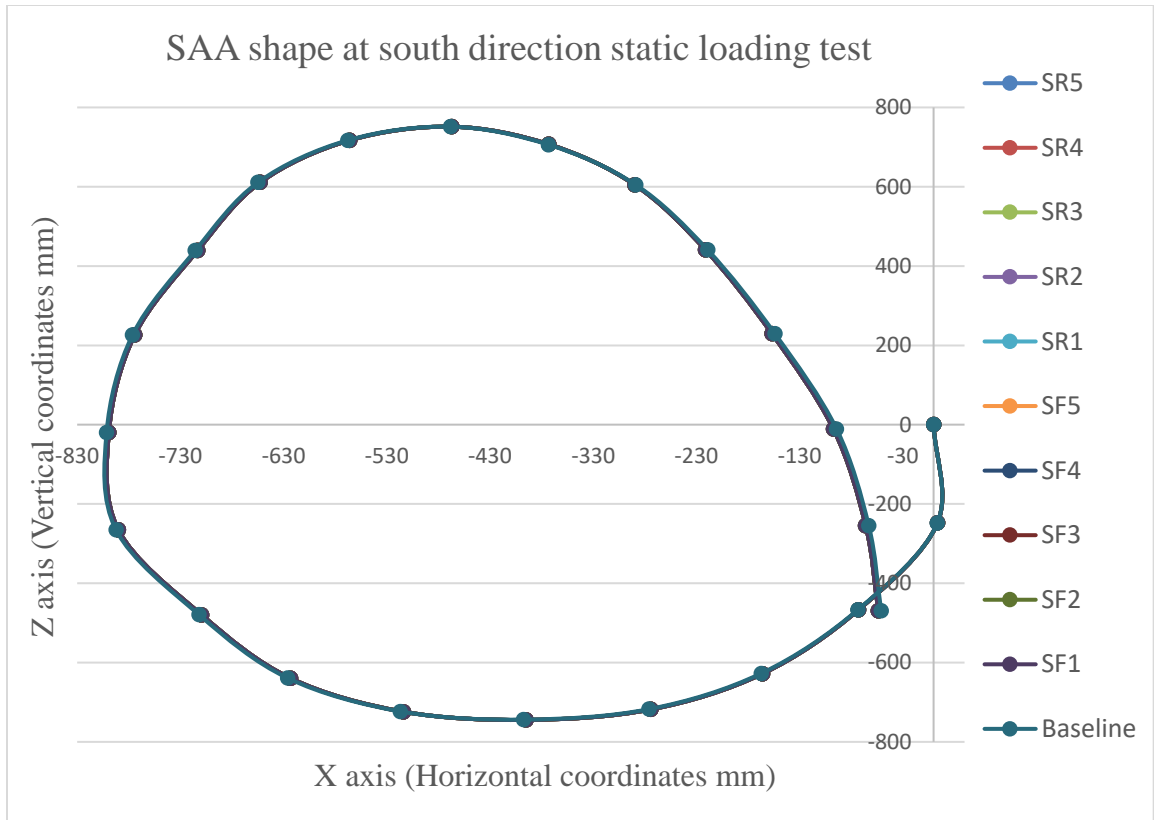
Figure 3.13. shape of culvert based on recorded coordinate by ShapeArray. Baseline (without loading) and 10 loading positions in south direction before lining application.

The baseline data and the additional 10 loading positions after lining application differ slightly in both the north and south directions, as seen in Figures 3.13 and 3.14, and all of the displacement readings are practically identical.

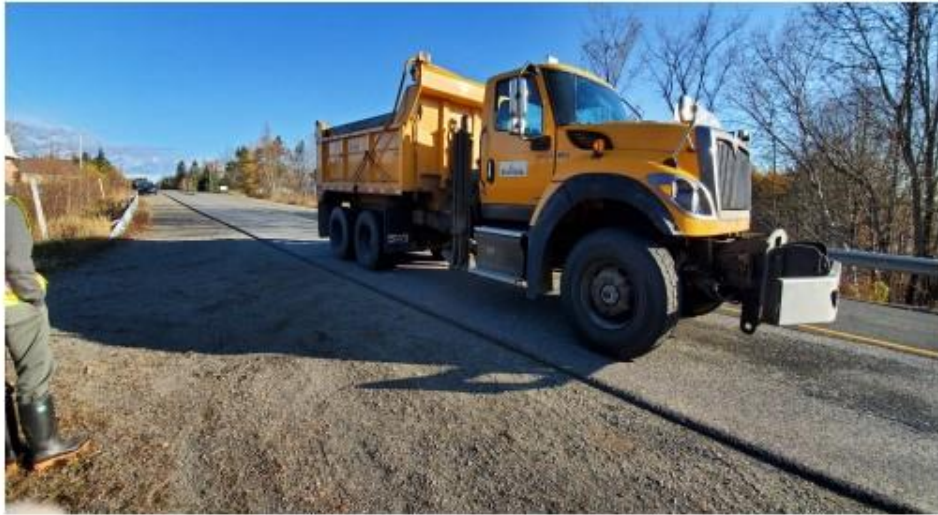
Picture 1. NBDTI Vehicle - Loaded Plow Truck.

The assignment consisted of two parts: "Unlined" culvert scans and post "Lined" culvert scans. The Unlined scans were to set a baseline and was conducted on November 03rd. Four complete scans were conducted on November 03rd, consisting of an unloaded scan and then continuing to loaded scans. The unloaded scan was conducted without any additional loading of the crown of the culvert. Then a loaded

vehicle (Picture 1.) was statically placed at three predetermined positions seen in Picture 2, Picture 3, and Picture 4 below. A full scan of the culvert consisted of a 5-metre section of the length of the culvert. This 5-metre section was located 2.5-metres on either side of the Centre of the West (south bound) lane of Route 127. Each full scan began at the eastern end of the 5-metre section moving towards the inlet end of the culvert. At 30 centimetre increments a 360 degree 2D LIDAR scan was captured along the 5 metre section resulting in 18 cross-sectional scans as seen in Figure 2 & 3 below.

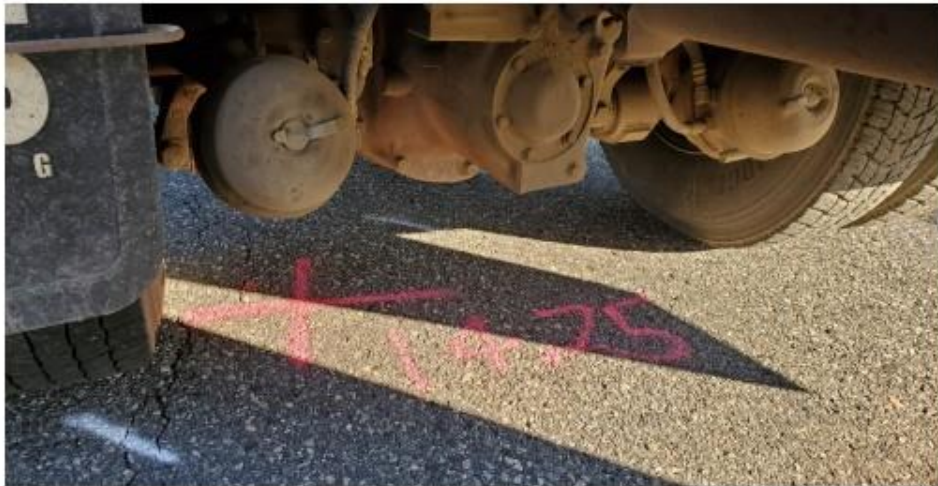
Picture 2. NBDTI Vehicle - Loaded Plow Truck at Static Location 8 – Front Rear Tandem Axle over Crown.

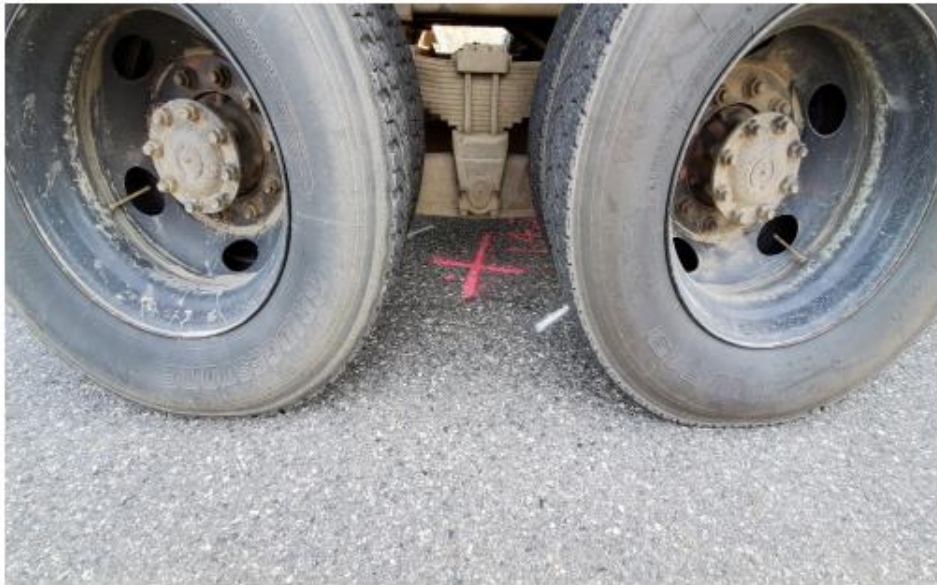
Picture 3. NBDTI Vehicle - Loaded Plow Truck at Static Location 9 – Rear Tandem Axles Centred over Crown.

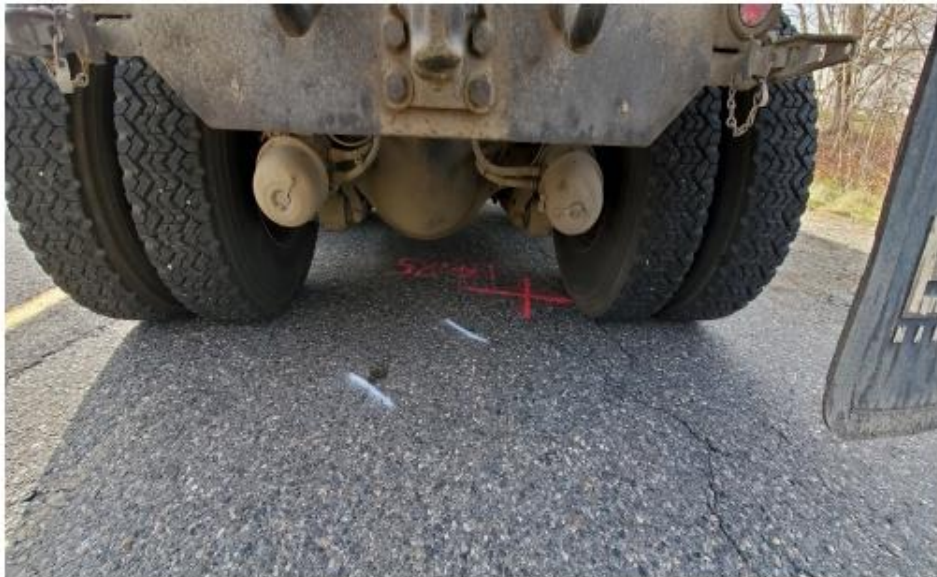
Picture 4. NBDTI Vehicle - Loaded Plow Truck at Static Location 10 – Rear Tandem Axle over Crown.

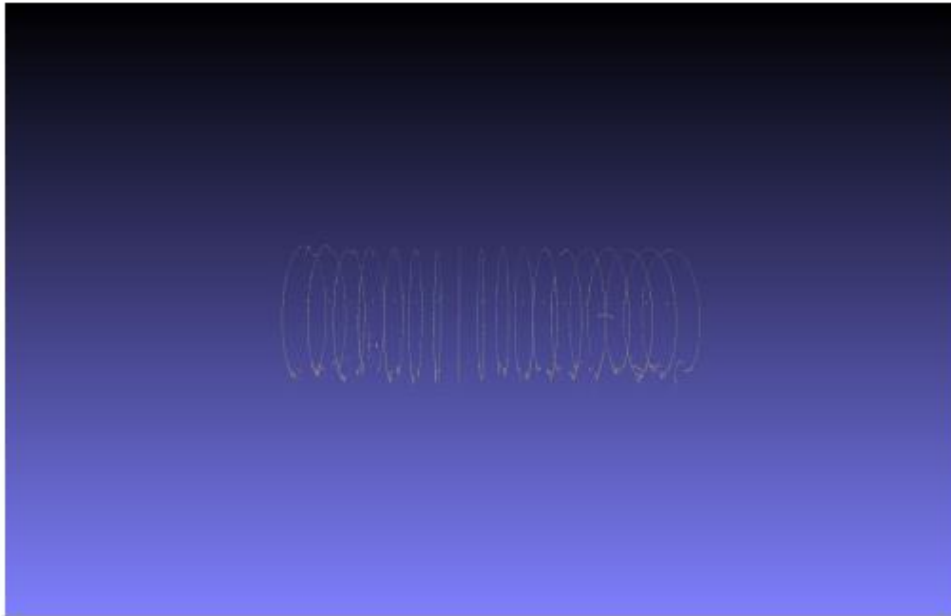
Figure 2. 18 LIDAR scanned cross-sections of a 5-metre section of CSP.

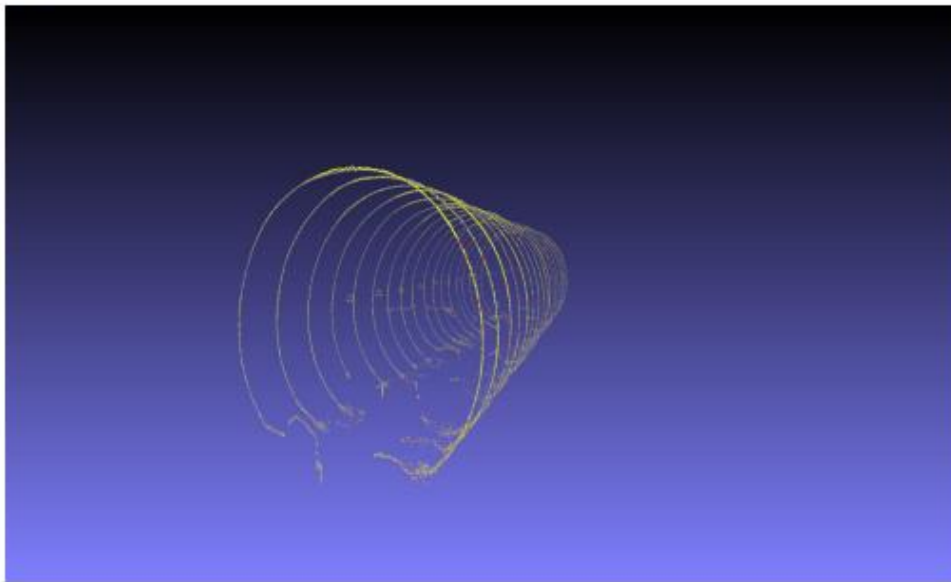
Figure 3. 18 LIDAR scanned cross-sections of a 5-metre section of CSP.

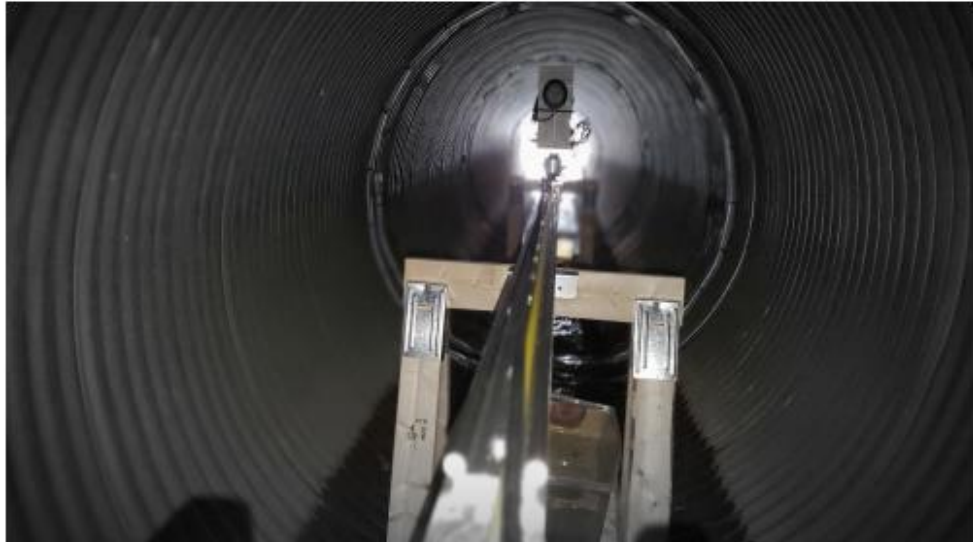
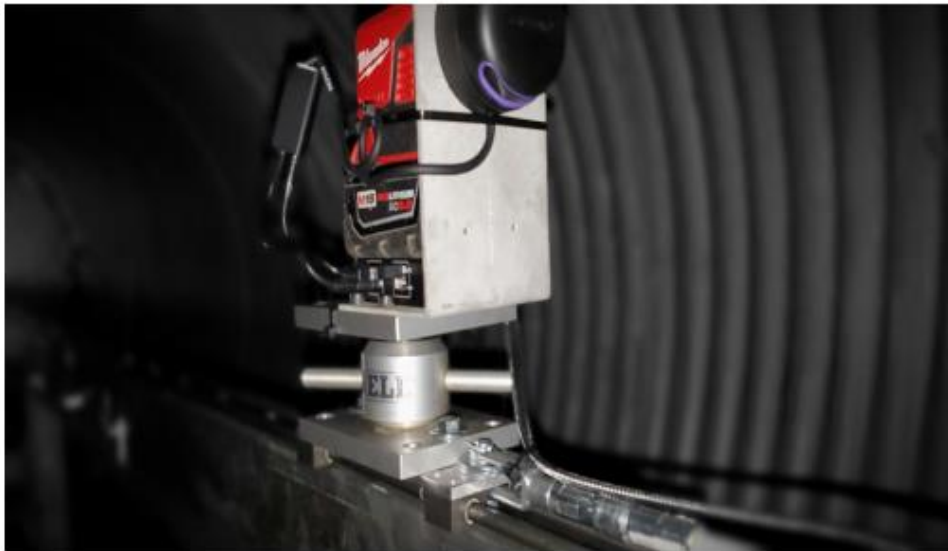
Picture 5. *LiDAR mounted to railing system.*

Picture 6. *LiDAR mounted to railing system.*

Picture 7. LIDAR mounted to railing system.

Picture 8. LIDAR mounted to railing system.

The LiDAR scanner was pulled through the 5-metre section along a sliding rail system as seen in **Picture 5**, **6**, **7** and **Picture 8** below. The rail system was bolted to a rectangular aluminum tube and then fastened to two sawhorses. The two sawhorses had plastic containers with approximately 30 kilograms of water on each platform stabilizing them.

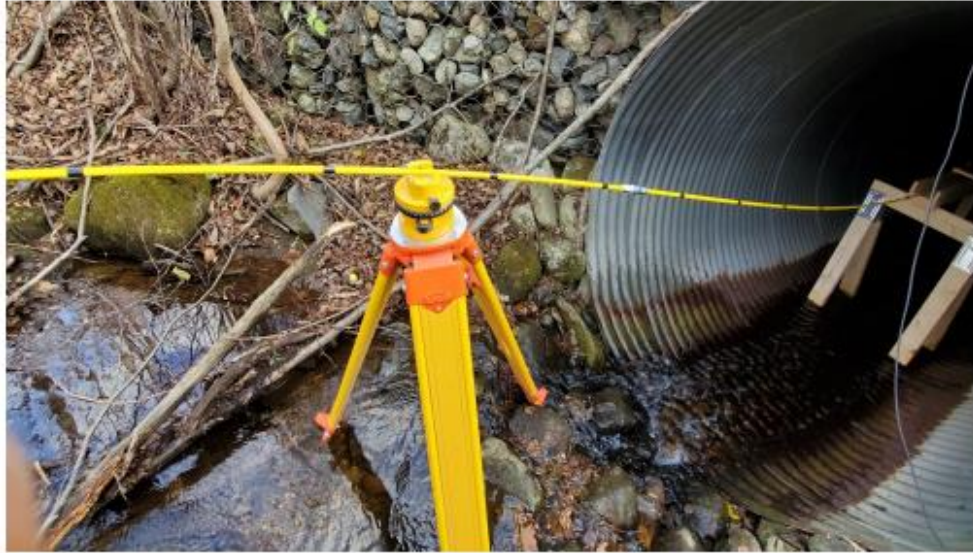
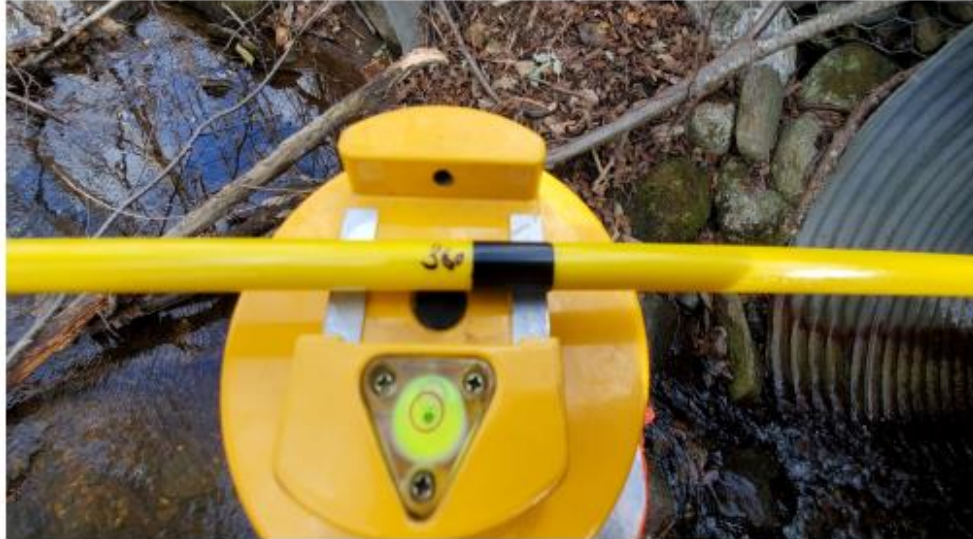
Picture 9. Tripod near the inlet of the CSP as a reference for incrementing the LIDAR between full scans.

Picture 10. Tripod near the inlet of the CSP as a reference for incrementing the LIDAR between full scans. Marking along the fibre glass pull rod to make Z axis locations.

A tripod was affixed near the inlet to the CSP (Picture 9.) and used as a reference point to ensure each full scan was at the same Z axis location. The fibre glass pull rods were marked and stopped at 30 centre increments (Picture 10.).

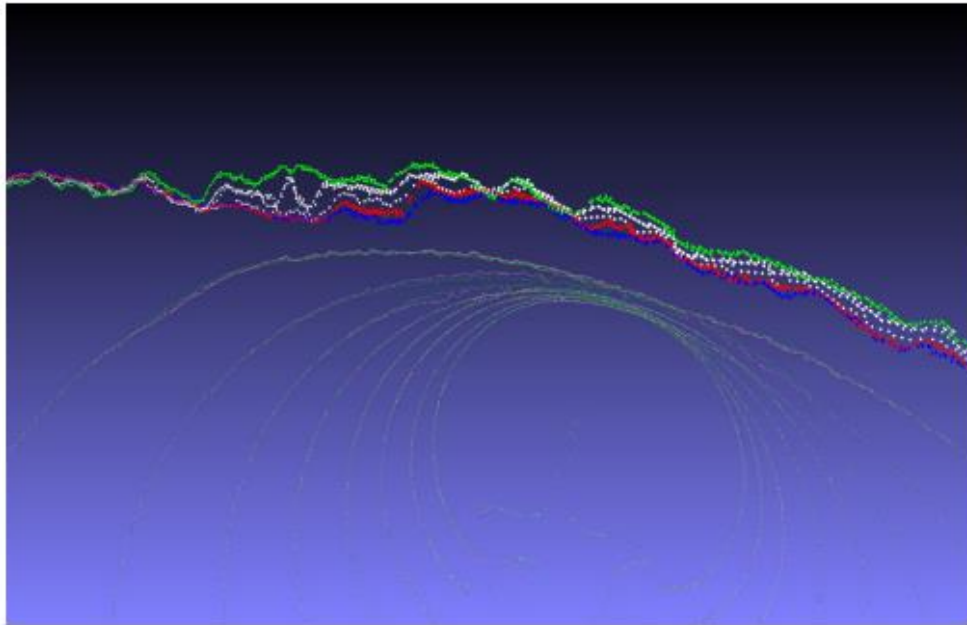
Figure 4. Cross-sectional LIDAR scan of "Lined" CSP – The Green points are the unloaded baseline scan while the other coloured points represent the three statically loaded positions described above in Pictures 2, 3 and 4.

Examples of the LIDAR crosssectional scans are seen below in Figures 3 and Figure 4 below.

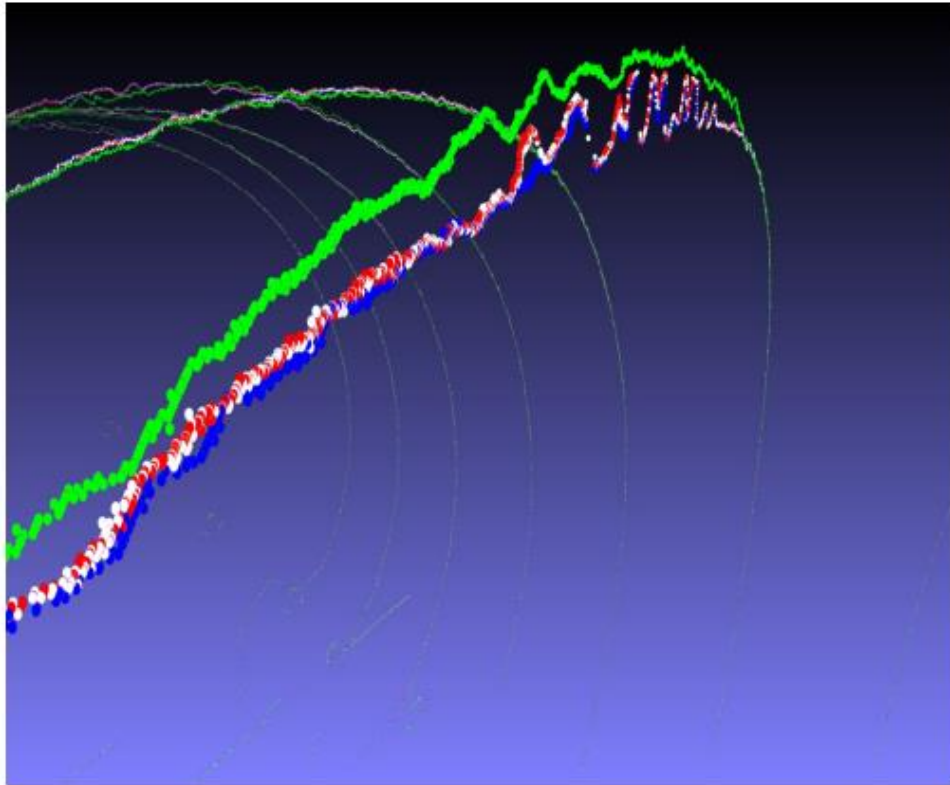
Figure 5. Cross-sectional LIDAR scan of "Lined" CSP – The Green points are the unloaded baseline scan while the other coloured points represent the three statically loaded positions described above in Pictures 2, 3 and 4.
